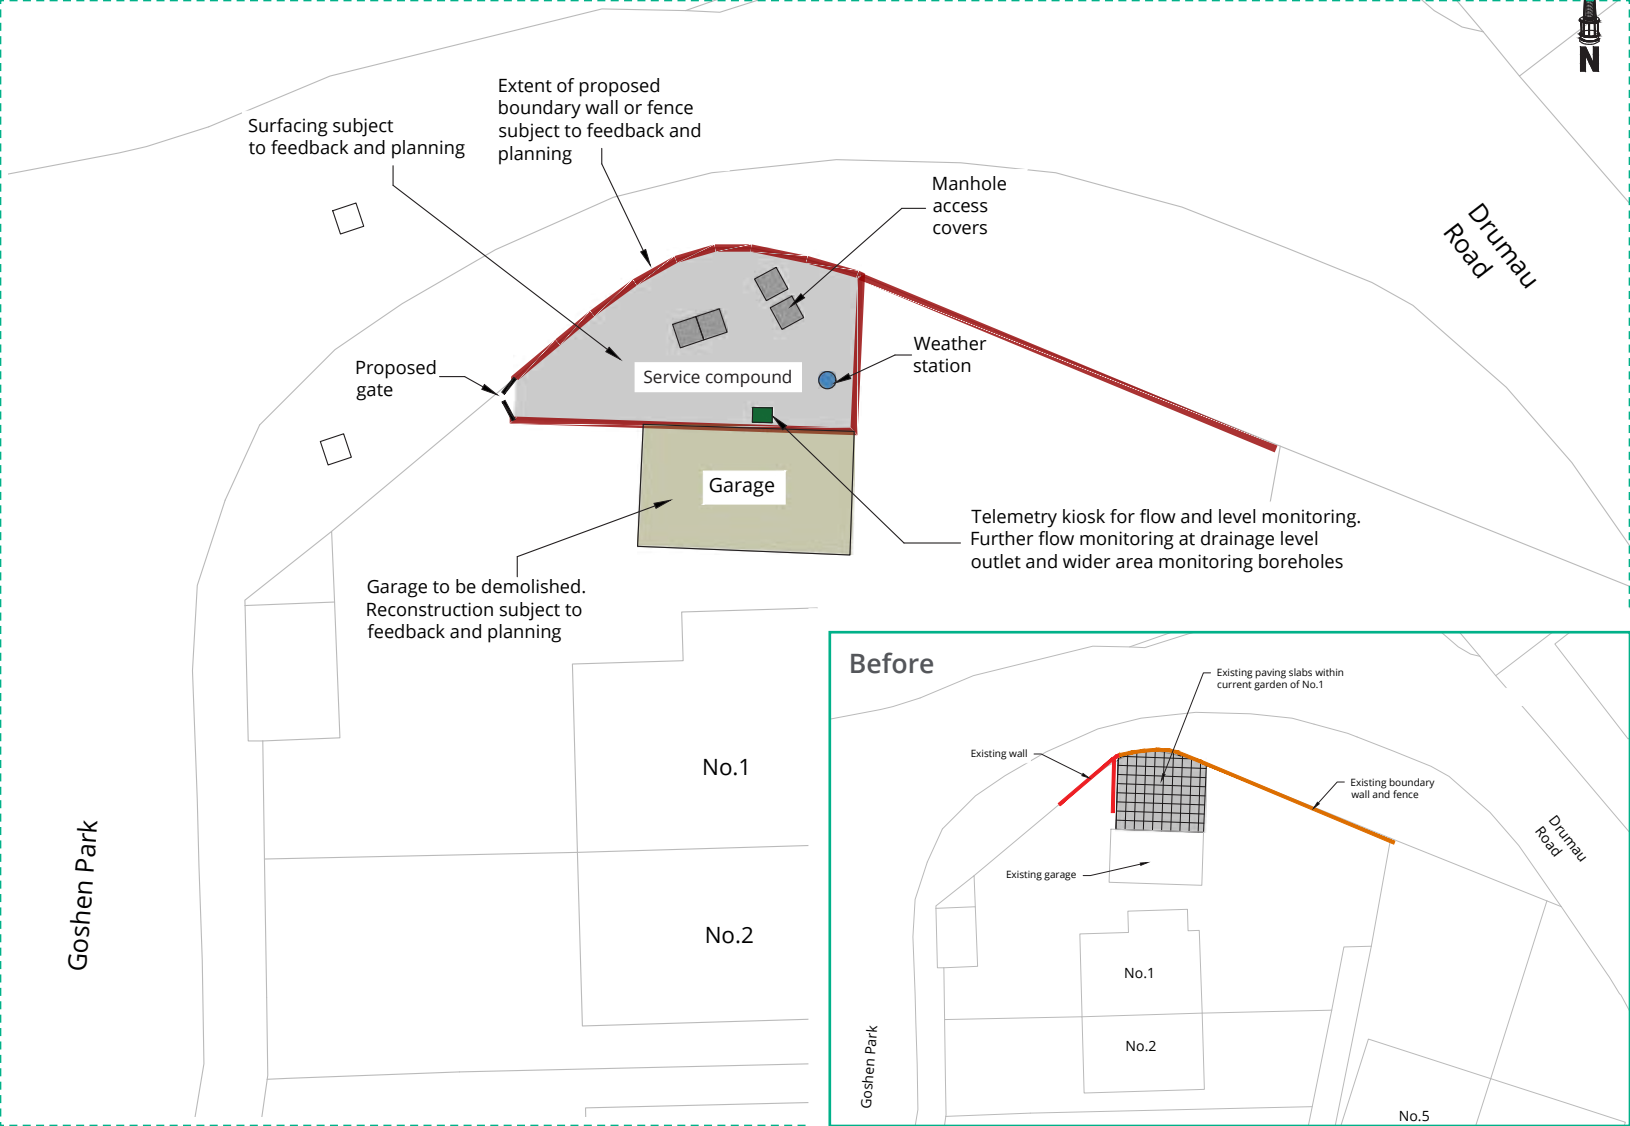
Surfacing subject to feedback and planning

Extent of proposed boundary wall or fence subject to feedback and planning

Manhole access covers

Service compound

Weather station

Telemetry kiosk for flow and level monitoring. Further flow monitoring at drainage level outlet and wider area monitoring boreholes

Garage to be demolished. Reconstruction subject to feedback and planning
